**REITZ & JENS, INC.**  
CONSULTING ENGINEERS

December 8, 2010

Re: Site Visit / Spillway Inspection – December 2, 2010

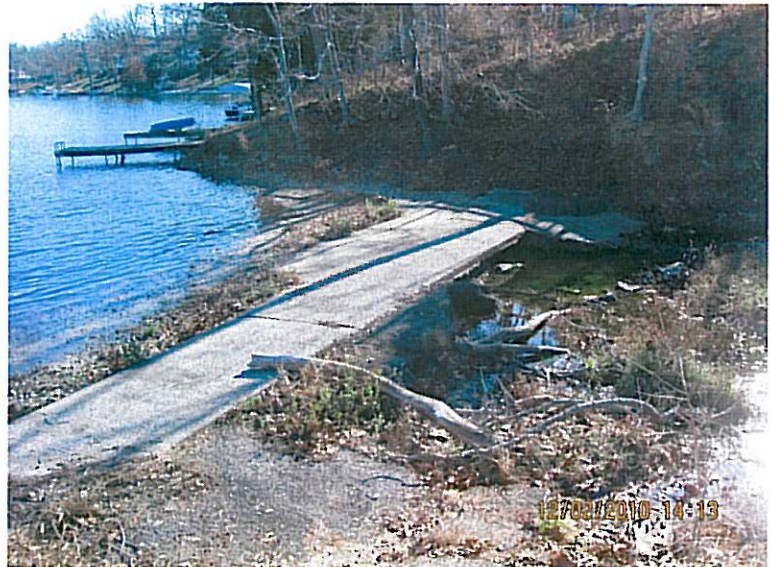
The photo on the right shows the existing spillway control crest. The crest has been undermined on the downstream side and there is evidence of seepage under the concrete crest slab. The protective apron on the downstream side has been washed out, probably over the location of the unknown backfill used to plug the trench cut into the spillway in 1981 when the lake had to be lowered at the request of the State Dam Safety Engineer. The field measured effective length of the spillway is about 58 feet, the concrete slabs are about 4 feet wide and appear to be no more than 12 to 15 inches thick. There is no visible evidence of a cutoff wall below any part of the spillway control crest.

The undermining of the spillway crest and the lack of a cutoff wall below the crest apron should be improved by replacement of a new spillway crest with a minimum 6 foot deep cutoff wall. We have prepared a typical section of the recommended replacement; these plans are attached to this memo and were previously sent to the committee. The top width of the spillway is not fixed, it can be varied to suit the needs of the membership. The spillway **MUST** be rebuilt no higher than the elevation of the present spillway, in order to avoid obtaining a permit from the MO Dam and Reservoir Safety Council. Replacement of the deteriorated spillway crest at the same elevation is considered routine maintenance and will not require a permit.

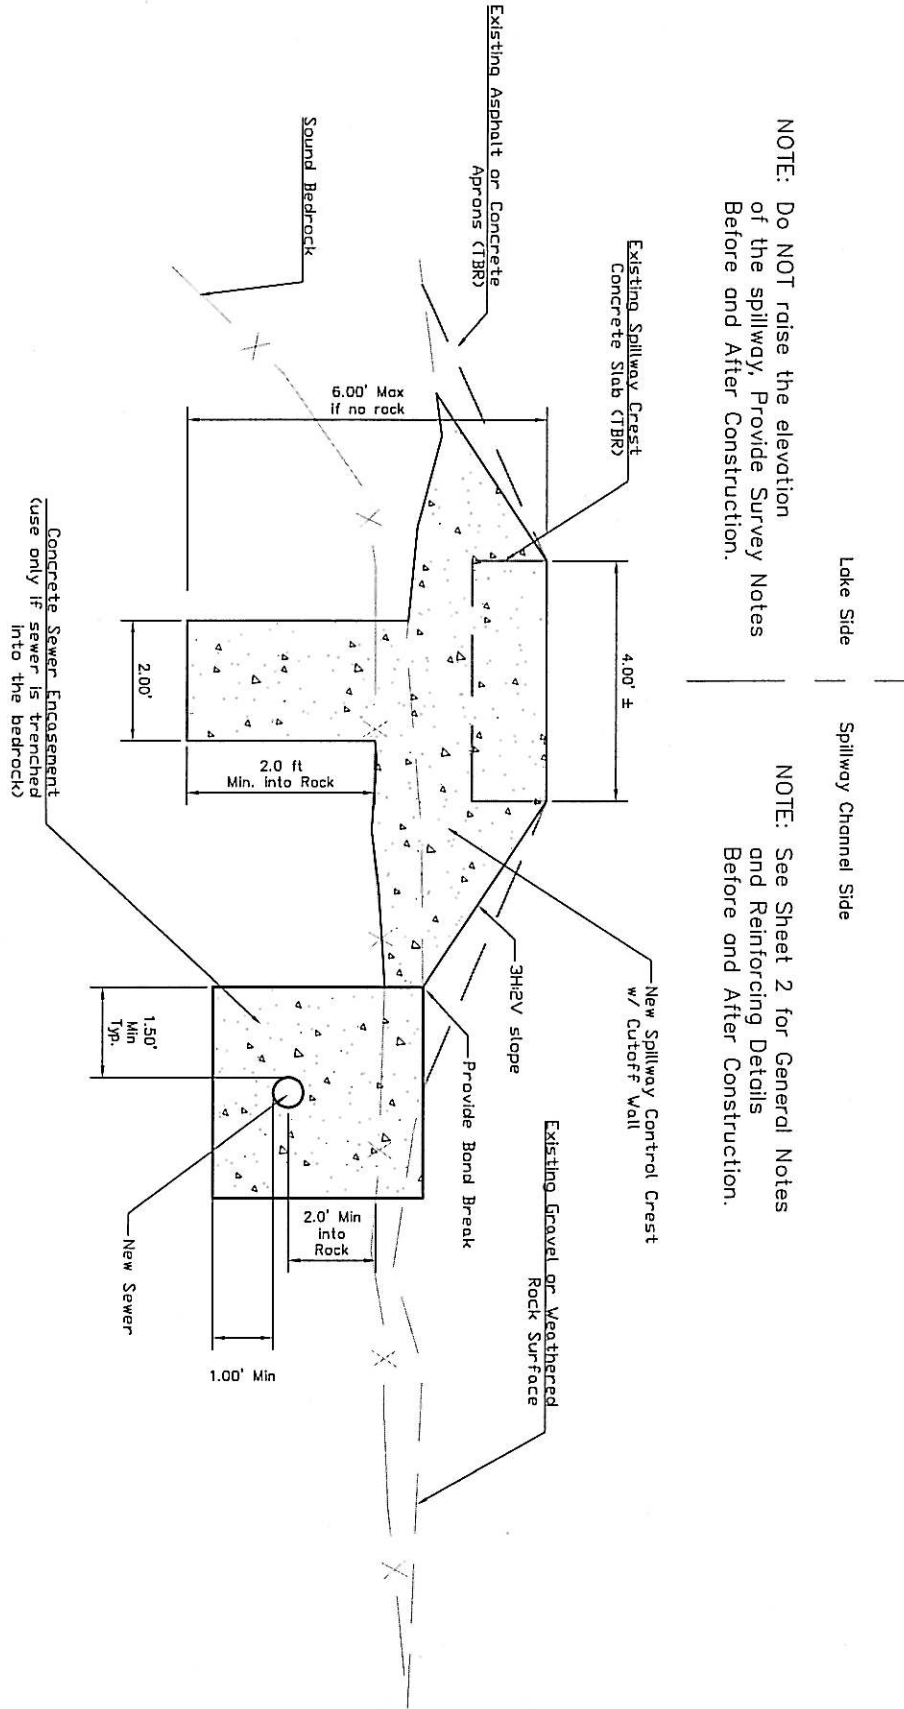
Section thru Spillway & ForceMain

Discussion with the sewer contractor indicated that the sewer is planned to cross the spillway area downstream of the spillway control crest. We have included a suggested method of crossing through the rock if the contractor intends to trench the sewer across the spillway. If he intends to tunnel or bore the sewer across the spillway then the carrier pipe should be grouted into the rock. It is our opinion that either method of installing the sewer below the present spillway channel grades will not require a permit from Missouri Dam Safety.

We strongly recommend that any sewer crossing of the dam alignment be at an elevation above the permanent pool elevation, to avoid the probability of creating a seepage path through the dam.

If concrete sewer encasement is used, it should be a minimum of 5 feet from the spillway cutoff trench.

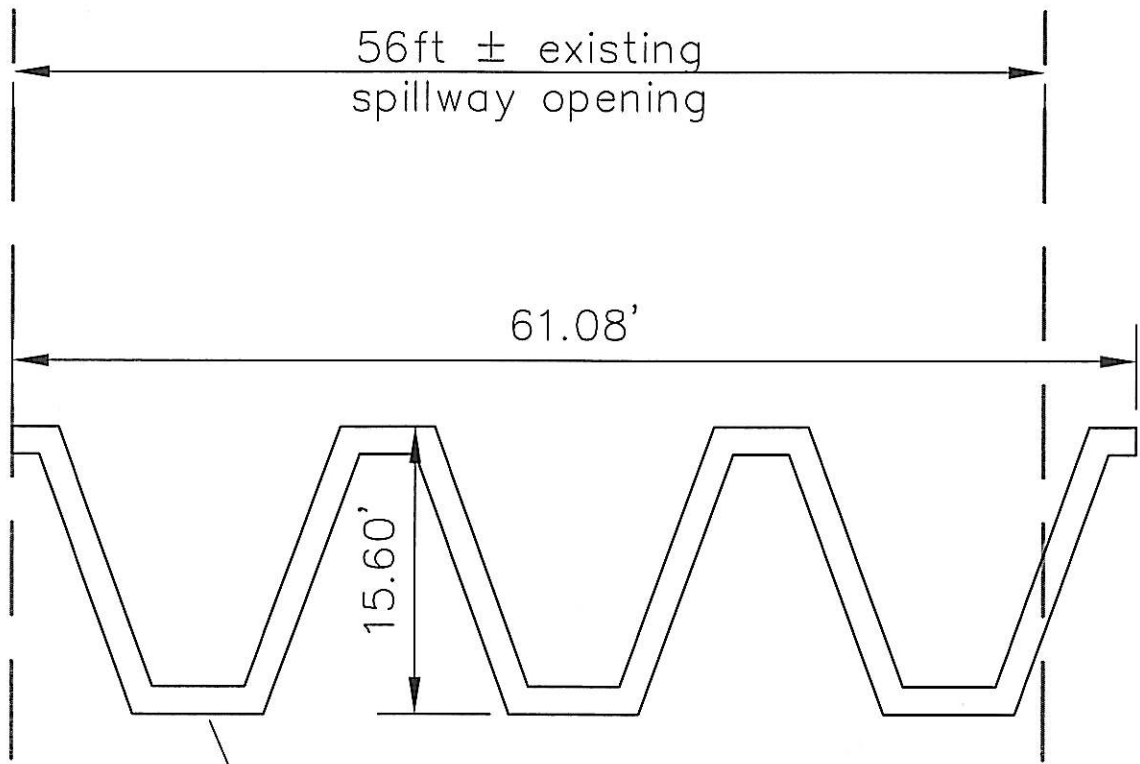
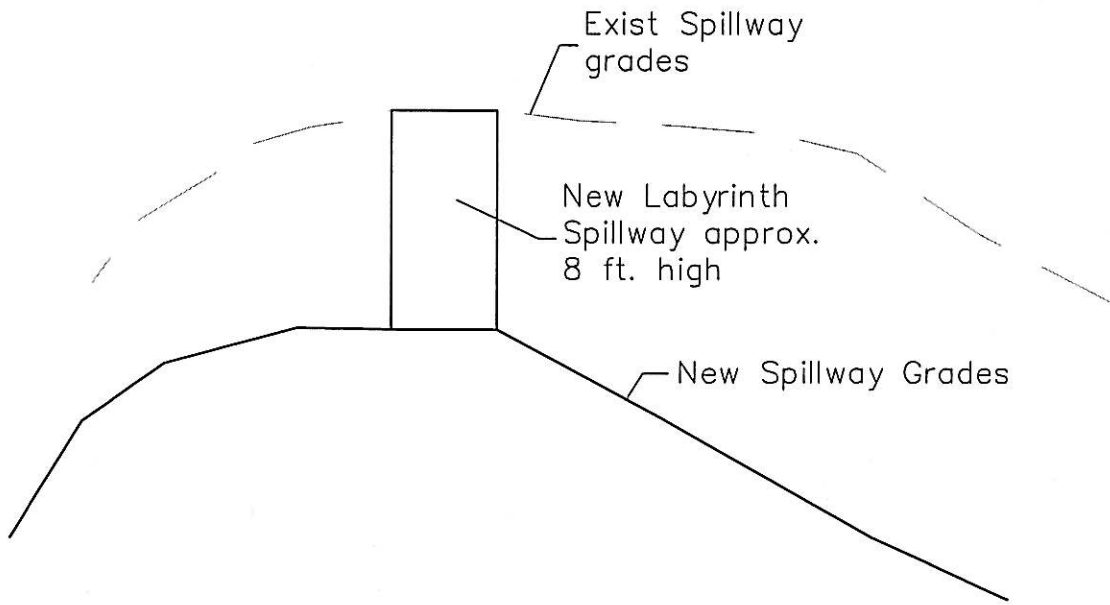
Lake Tishomingo  
Approx Weir Geometry

A detail sheet of a labyrinth spillway is shown on the next page, this sheet was handed out at the meeting. This spillway type is a way to effectively lengthen a narrow spillway without significantly widening the actual spillway location, however to make these work the spillway channel will have to be deepened, preliminary computations show that the deepening may be as much as 8 feet. The planned presence of the sewer crossing may affect the constructability of this labyrinth option.
