RE: Lake Tishomingo Dam (MO 30039) Jefferson County

COVER SHEET

Inspection Checklist

Photographs of MO30039 on May 27, 2020

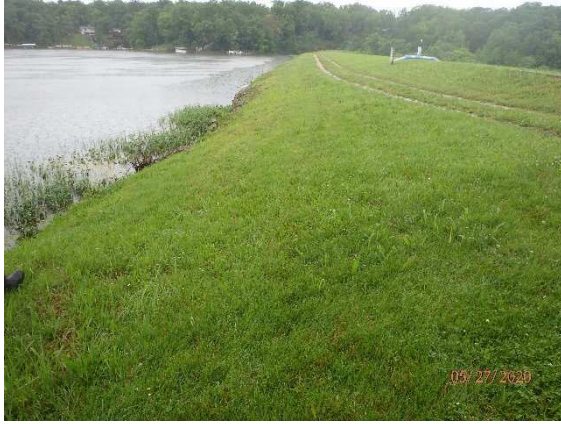
Upstream face

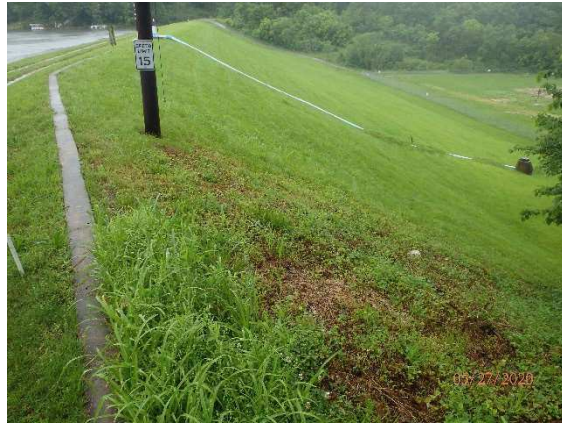
Downstream face

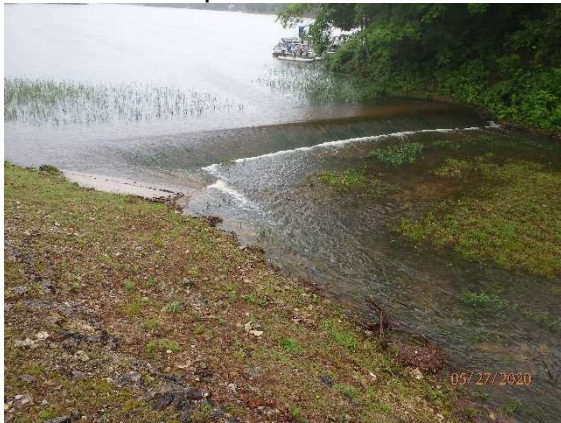
6. Toe of dam	NP		
7. Principal spillway	NP		Great job on the spillway maintenance.
8. Principal spillway channel	NP		Great job on the woody vegetation removal.

Principal spillway crest

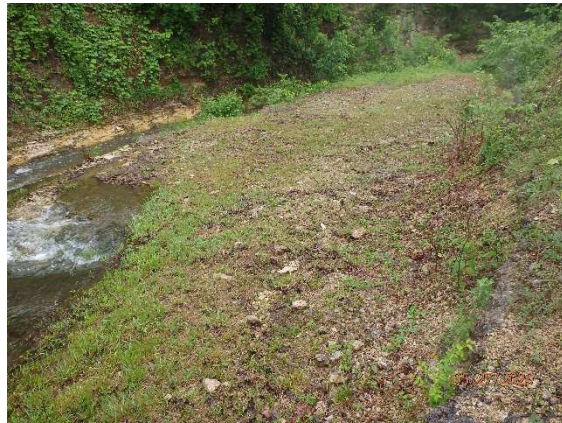
Principal spillway channel

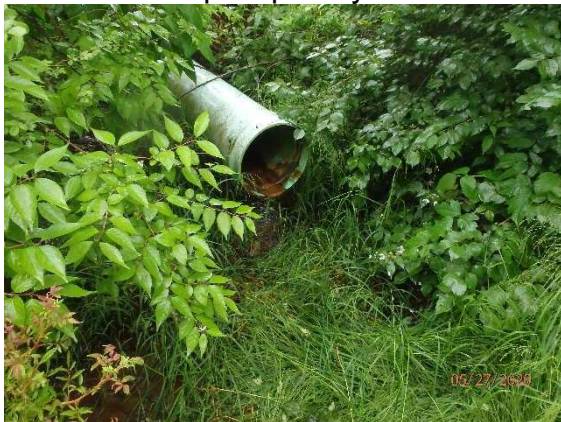
Embankment drain outlet with excess vegetation to remove

9. Emergency spillway	NA		
10. Emergency spillway outlet channel	NA		
11. Embankment drains	MR	Vegetation	Clear the excess vegetation from around the outlet pipe to allow proper access and visual inspection. (Flow from drain at the inspection was less than 5 gallon/minute.)

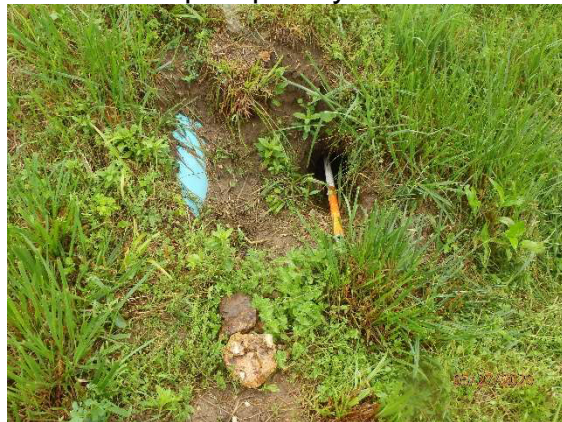
Groundhog burrow to excavate and fill

Item	Condition*	Issue	Comments
1. Upstream face/riprap	NP		
2. Crest	NP		
3. Downstream face	MR / OR	Varmint holes / Uneven surface	Groundhog holes were noted on the downstream face of the dam; just left of the mid-point of the slope and around the siphon pipe. Excavate and fill the burrows with compacted clay material and make efforts to discourage future rodent activity. / Monitor the uneven surface of the left 1/3 of the embankment for any changes or movement; such as signs of surficial sliding or scarps.

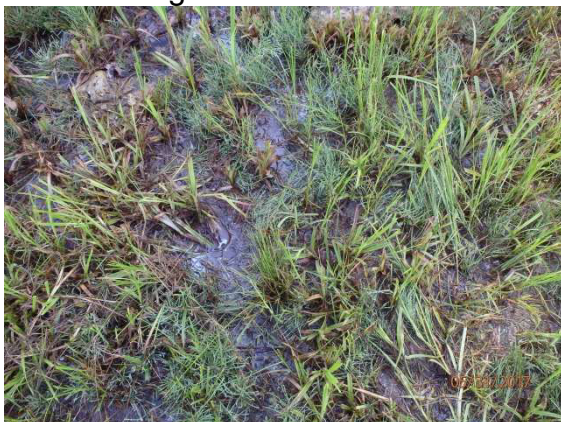
Seepage in right groin near toe (2017 photo)

4. Left groin	NP		
5. Right groin	OR	Seep	There is evidence of seepage (hydrophitic vegetation and standing water with iron oxidizing bacteria/orange staining) in right groin, approximately 2/3 downslope from the crest. Monitor regularly and if there is any change in color or flowrate, contact the Dam and Reservoir Safety Program.

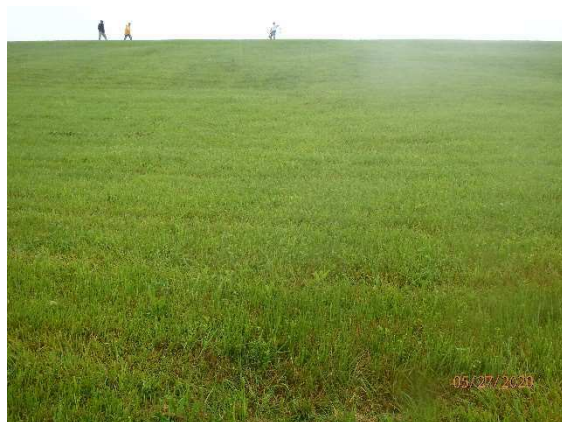
Uneven surface on downstream face to monitor for movement/change
