Lake Monitoring 2023

Prepared for Lake Tishomingo by Gateway Lake Management LLC

Visit Date: Thursday 4/20/2023

Visit 2 Observations

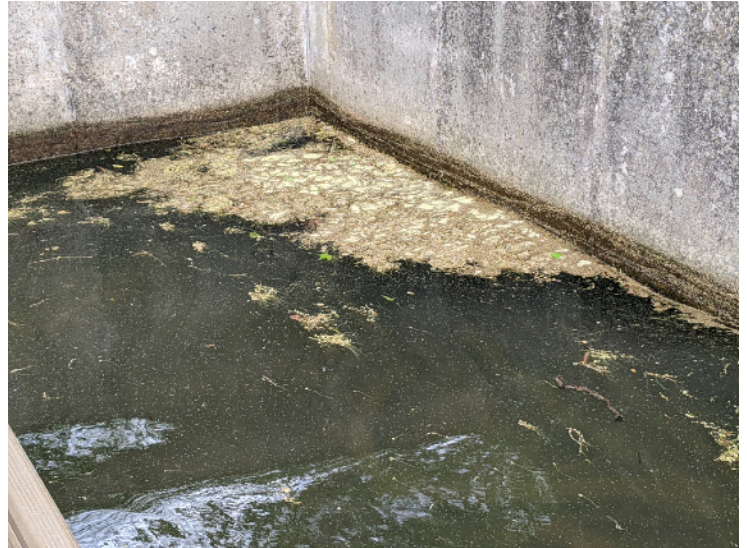
Picture 1

Pollen from trees was the main culprit of the negative aesthetics of the lake (as seen in picture 1). This can be seen as tiny tan flecks on the surface or in coves it can congregate.

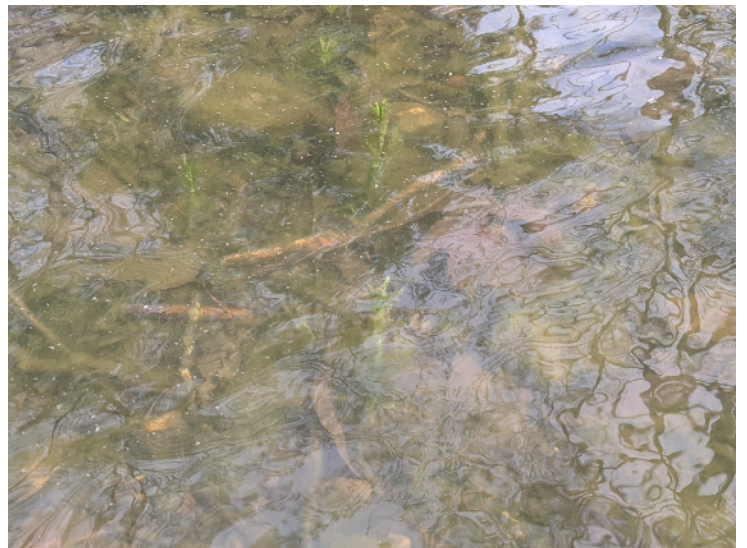
Picture 2

Water willow can be seen sprouting just under the surface in the few areas around the lake where it is desirable (See picture 2). The lake is in good shape for this time of year and hopefully this trend continues.
