# Lake Monitoring 2023

Prepared for Lake Tishomingo by Gateway Lake Management LLC

Visit Date: Thursday 5/4/2023

## Visit 3 Observations

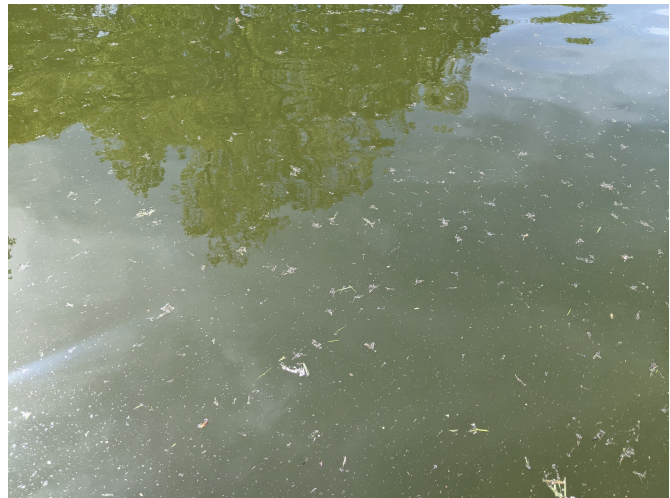
Picture 1

The planktonic bloom is on the moderate side and gives the water a green hue as seen in picture 1. Tossing the rake in various places shows a small amount of filamentous algae as seen in picture 2. The great news is that southern naiad and pondweed is not present. Other lakes I manage that grow naiads and pondweeds have already got a decent amount to spray.
