Lake Monitoring 2024

Prepared for Lake Tishomingo by Gateway Lake Management LLC

Visit Date: Tuesday 5/7/2024

Visit 3 Observations

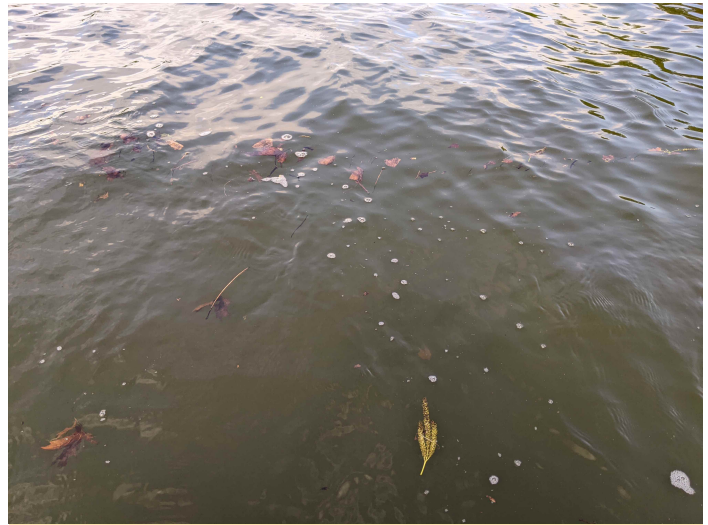
Picture 1

The first visit in May came after some decent rains with more heavy rain expected for tomorrow. Water was murky with about 2 feet of visibility near the boat ramp and 3-4 feet by the dam. Debris from trees was the main issue with twigs and branches floating around the entire lake (as seen in Picture 1).

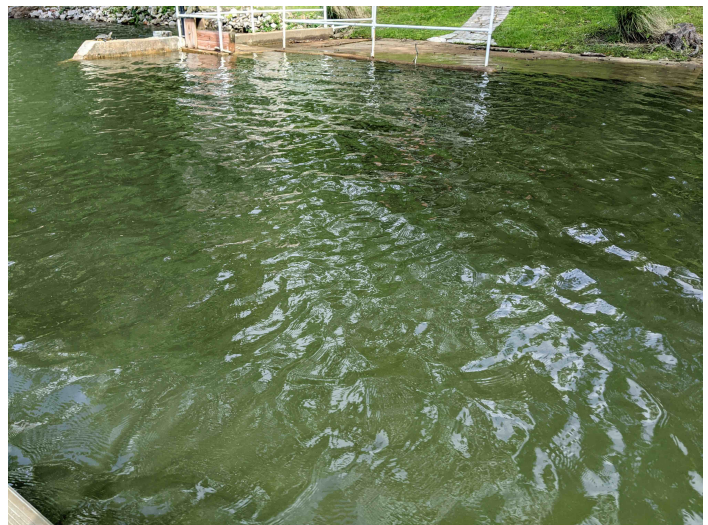
Picture 2

High water levels are causing some issues with not only debris but also some anchored docks becoming partially submerged (as seen in Picture 2). Boaters should be cautious as some larger limbs and tree parts are floating in the main lake and that trend will continue with more heavy rain expected.

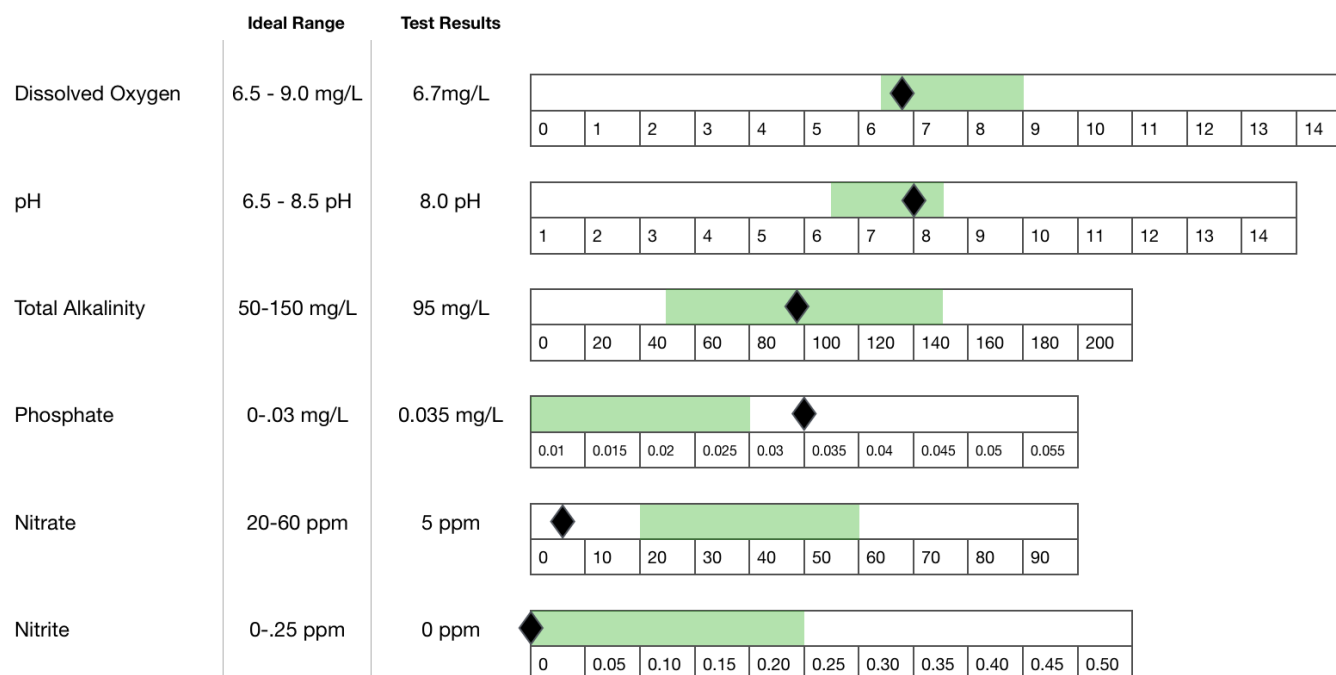
Figure 1

Overall the lake has minimal vegetation and water parameters are good with nutrient levels in check and oxygen levels high. I would expect fishing conditions to improve later in May once these cold fronts pass over and water temperatures climb into the 70's.

The water test was collected near the center of the lake.

Sample Collected: 5/7/2024 @ 10:13AM

Weather Conditions: Partly Sunny 70°F
