# Lake Monitoring 2023

Prepared for Lake Tishomingo by Gateway Lake Management LLC  
Visit Date: Friday 6/2/2023

## Visit 5 Observations

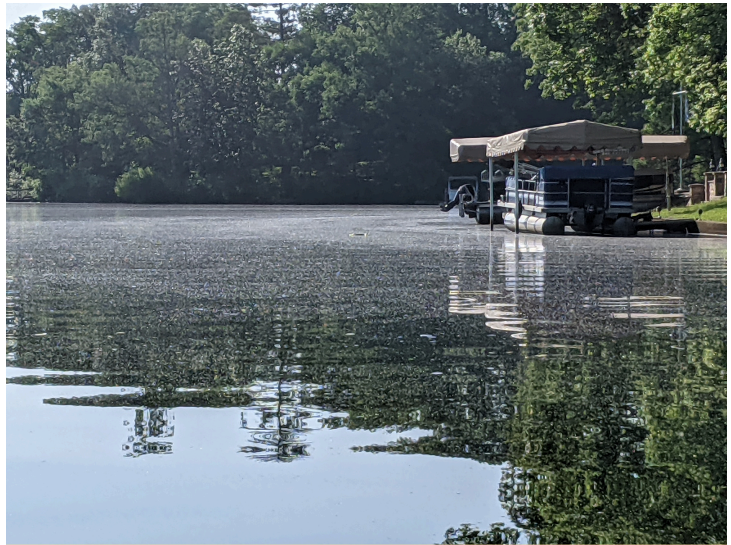
Picture 1

The lake did appear to have a bit of surface film or detritus on top in some locations. This was mostly tree pollen and dead midges/gnats (as seen in picture 1). In another cove on the west side the surface debris was mostly grass clippings (as seen in picture 2).
