# Lake Monitoring 2023

Prepared for Lake Tishomingo by Gateway Lake Management LLC

Visit Date: Tuesday 6/20/2023

## Visit 6 Observations

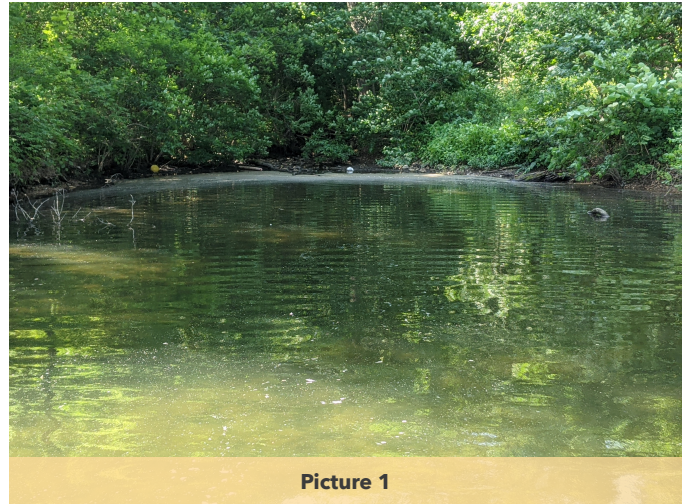
Picture 1

Water clarity continues to improve on this visit with some areas as great as 7-8ft depth of visibility. The north area around the dam and some eastern shores look the best. The western coves have some planktonic algae growth that the wind is blowing around causing it to build up in the backs of these coves (as seen in picture 1).

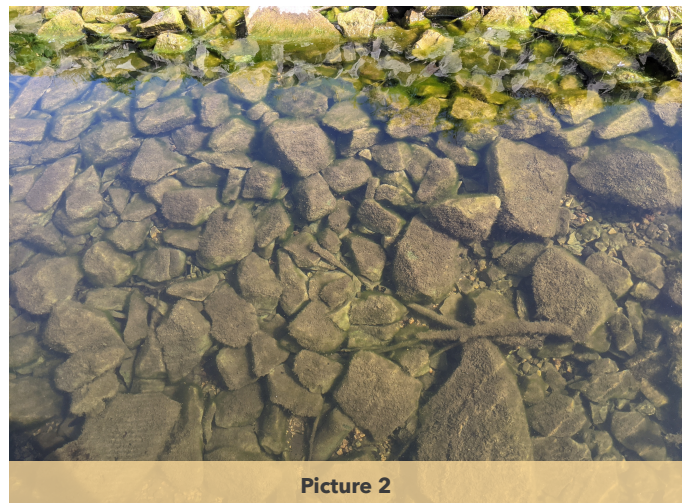
Picture 2

Filamentous algae growth is also slightly up with minor growth around rip rap shorelines (as seen in picture 2). Some vegetation growth is desirable because it contributes to the food chain. Without any vegetation at all fish growth would not be as good.

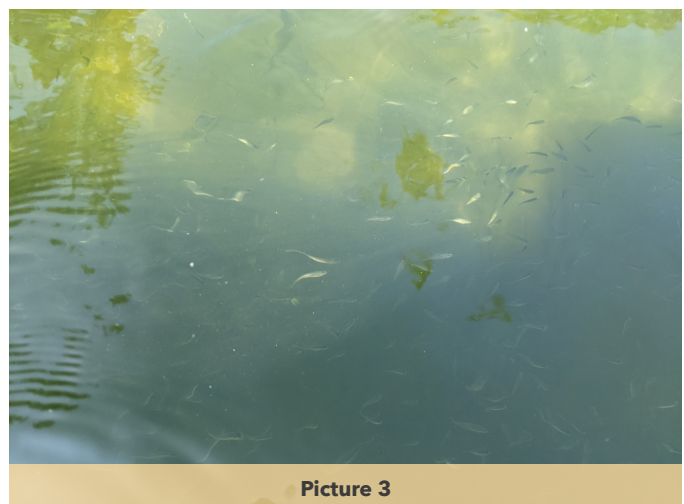
Picture 3

The conditions present are excellent for a recreational lake. Surface debris is slightly reduced from last visit but pollen and cottonwood seeds are still present. Small baitfish and minnows were very plentiful schooling around docks and even out in open water (as seen in picture 3). The throw rake was used in just about every cove coming up free of weeds. Looking great heading into July.
