# Lake Monitoring 2025

Prepared for Lake Tishomingo by Gateway Lake Management LLC

Visit Date: Wednesday 7/2/2025

## Visit 7 Observations

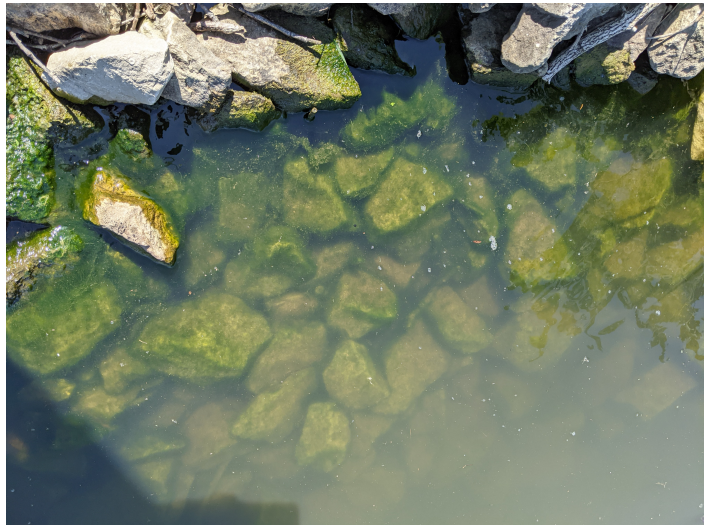
Picture 1

There has been a slight increase in filamentous algae in shallow rip rap areas since previous visits (as seen in Picture 1). This is to be expected given the amount of nutrients in the lake, which provides an environment for growth.

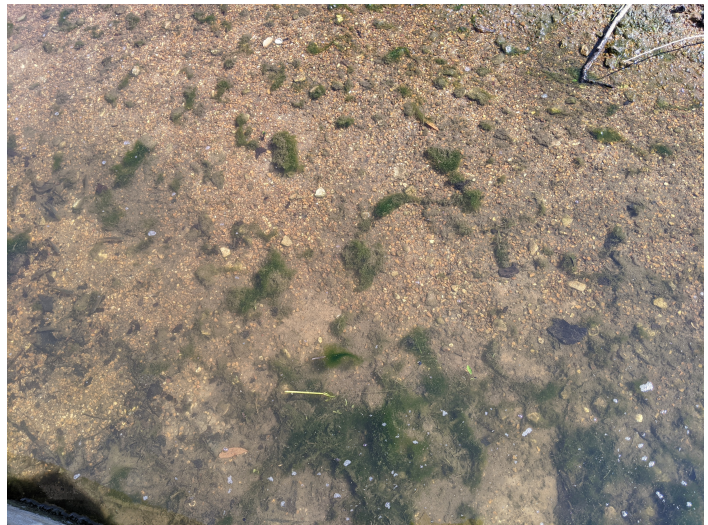
Picture 2

Overall vegetation is minor. The throw rake is coming up clean with no signs of submersed weeds. The backs of coves have a small amount of algae growing in the shallow spots (as seen in Picture 2).
