Lake Monitoring 2023

Prepared for Lake Tishomingo by Gateway Lake Management LLC
Visit Date: Wednesday 7/5/2023

Visit 7 Observations

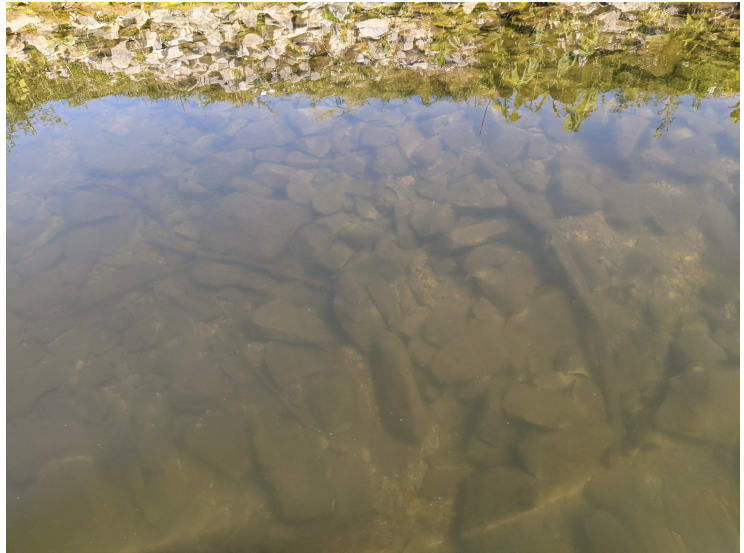
Picture 1

Water clarity on the southern half of the lake has been reduced from last visit. This comes primarily from the mild planktonic algae bloom and winds blowing from the north. This gives the water a greener hue and the individual suspended algae particles block visibility (as seen in Picture 1).

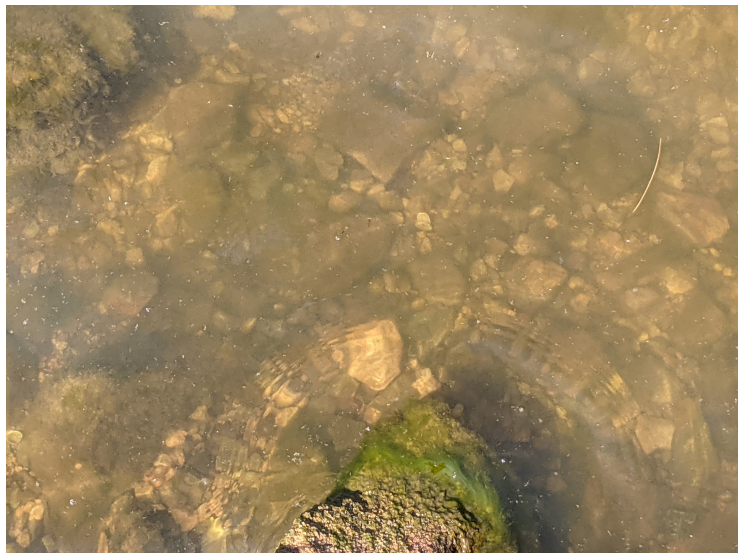
Picture 2

Filamentous algae is starting to come back slightly on rip rap and submerged rock in shallow waters. Very minor, but still a noticeable form of vegetation (as seen in Picture 2).
