# Lake Monitoring 2025

Prepared for Lake Tishomingo by Gateway Lake Management LLC

Visit Date: Thursday 7/17/2025

## Visit 8 Observations

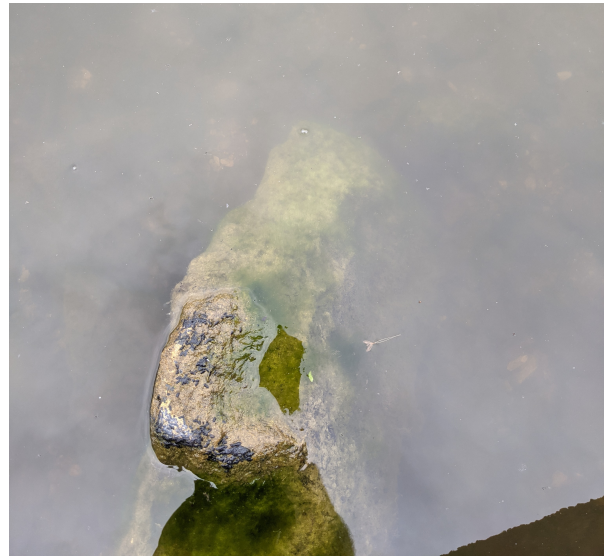
Picture 1

The filamentous algae is reducing but still visible on shallow dock areas and rocks (as seen in Picture 1). The water's surface is clean of vegetation but has many mosquito pupal case discards. Residents are likely to see an increase in mosquitos based on this observation.

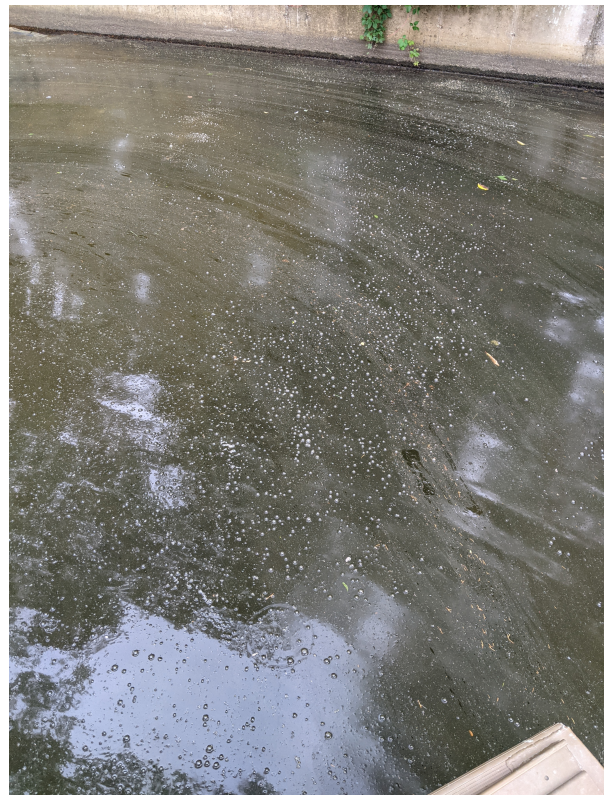
Picture 2

In shallow wind-blown coves, a small amount of film can be seen from detritus as it breaks down from natural processes (as seen in Picture 2). The weed rake continues to show no submersed vegetation.
