Lake Monitoring 2023

Prepared for Lake Tishomingo by Gateway Lake Management LLC

Visit Date: Wednesday 7/19/2023

Visit 8 Observations

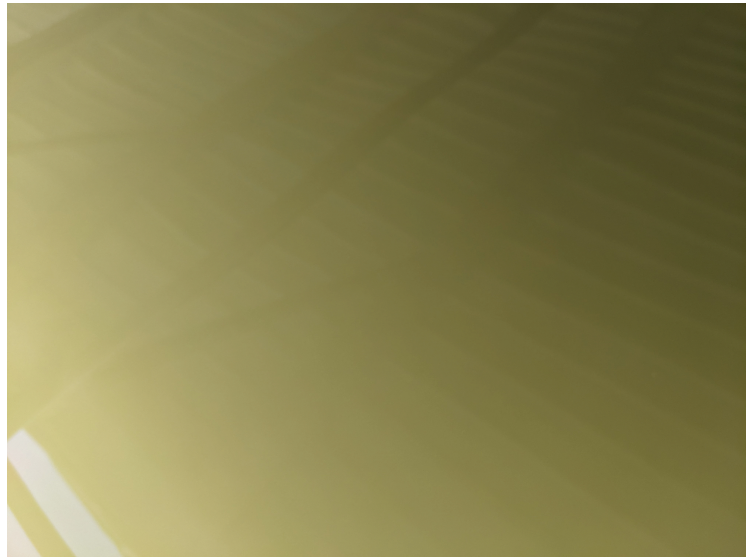
Picture 1

Rains have been hitting the area hard which helps to refill the lake to full pool, but in the short term the water has greatly reduced clarity. The southern 20% of the lake around the boat launch is very muddy/murky from the creek that feeds the lake. Visibility is around 1-2 feet (as seen in picture 1). The northern 80% of the lake has reduced clarity but isn't as bad at about 3 feet of visibility.

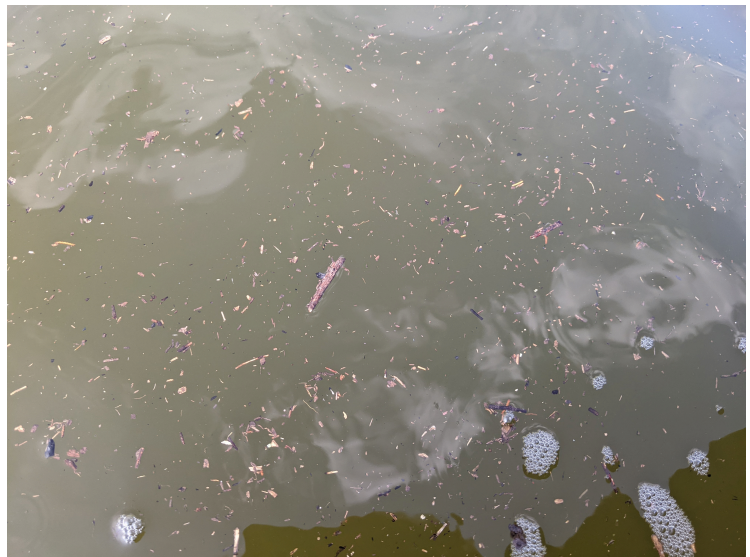
Picture 2

The planktonic bloom has been knocked out by the rains and filamentous algae is very scarce. The throw rake came up clean and free of weeds all around the lake. Vegetation wise the lake is excellent on this visit. Aesthetics wise the rains have caused some woody debris to be washed in, which is floating around the lake and congregating in wind-blown coves (as seen in picture 2). Things are going along great as we enter August.
