Lake Monitoring 2023

Prepared for Lake Tishomingo by Gateway Lake Management LLC

Visit Date: Friday 8/4/2023

Visit 9 Observations

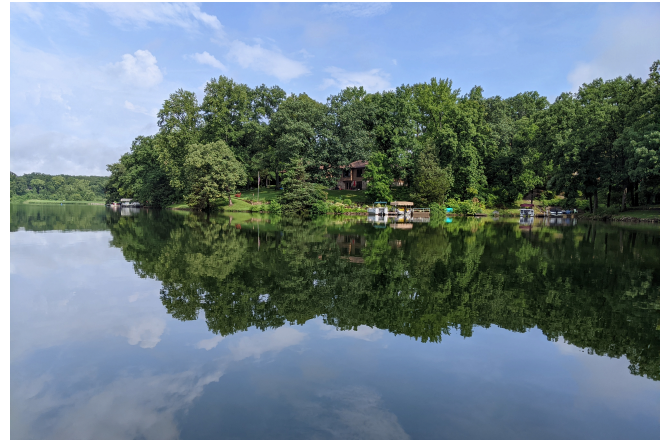
Picture 1

Despite the rains increasing and more on the horizon, the lake has 3-4 feet of visibility. Weeds are still non-existent and the throw rake is coming up completely clean all over the lake. From an aesthetics point of view the lake looks good (as seen in picture 1).

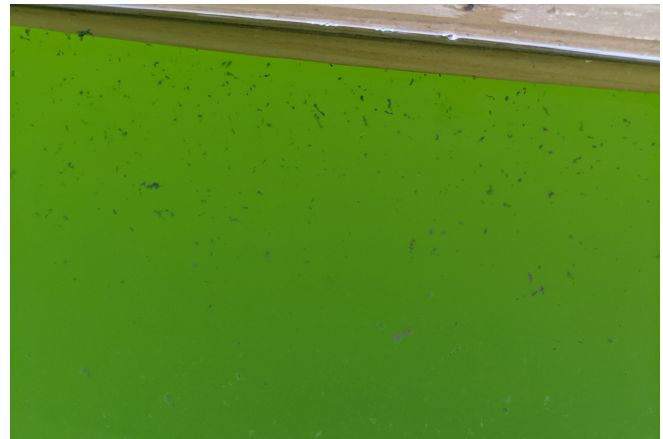
Picture 2

However, a minor planktonic bloom is slowly gaining traction. The southern 30% of the lake looks free of this bloom but in the rest of the lake it can be detected to some degree. In most areas you can only see it as tiny specs of green suspended in the water column (as seen in picture 2). When these specs reach high volumes, they coagulate and settle on the surface (as seen in picture 3). August is usually the worst month for planktonic blooms as temperatures rise. These blooms usually die off at some point in September as night temperatures drop into the 50s.

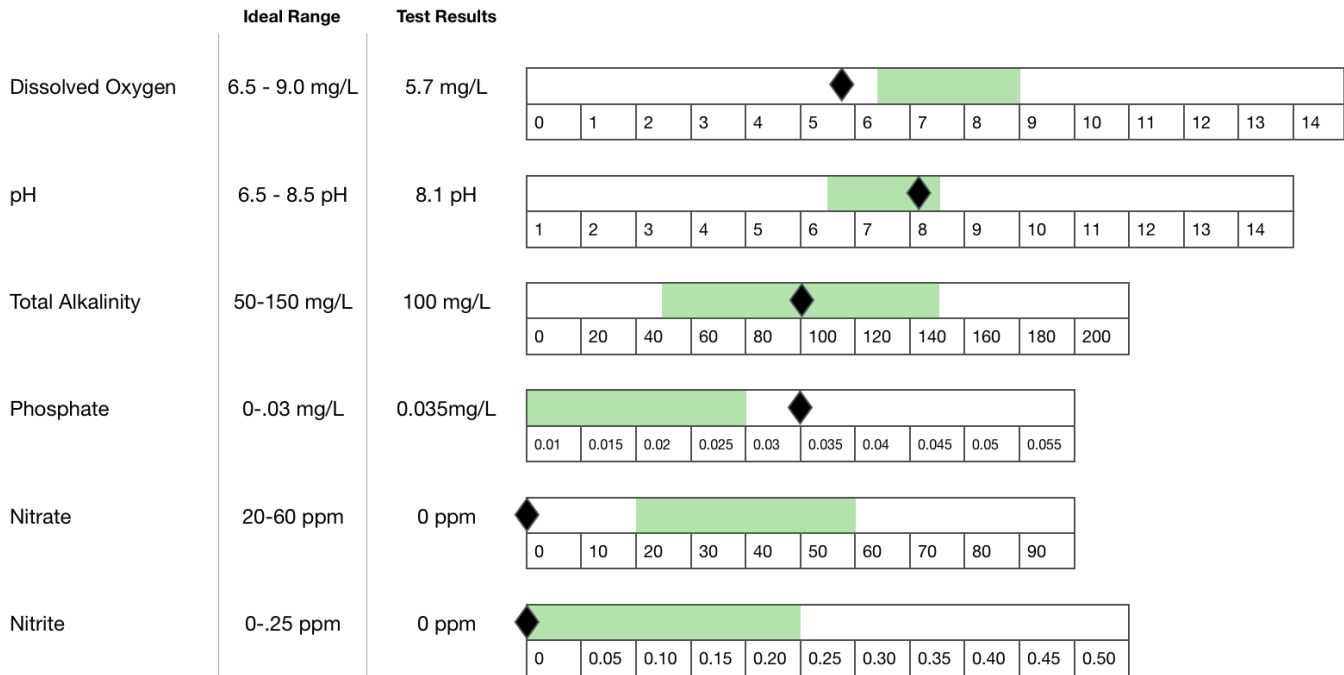
Figure 1

The water test was collected near the center of the lake.

Sample Collected: 8/4/2023 @ 10:12AM

Weather Conditions: Cloudy 75°F
