# Lake Monitoring 2025

Prepared for Lake Tishomingo by Gateway Lake Management LLC

Visit Date: Monday 8/18/2025

## Visit 10 Observations

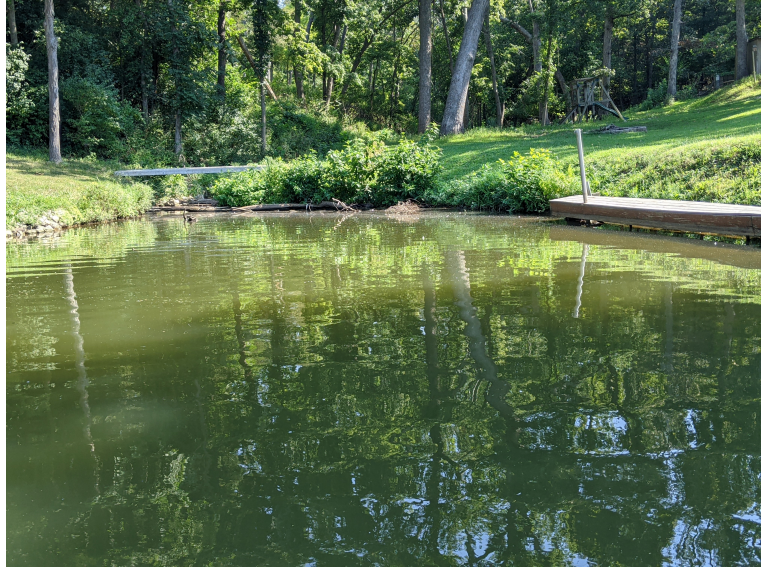
Picture 1

Even with recent warmer weather, the lake remains largely vegetation free of algae and submersed weeds. The only visual nuisance is a small amount of film/debris blown into the backs of some coves (as seen in Picture 1). The lake water parameters are in ideal ranges with oxygen levels at 6.9 mg/l and a pH of 8.4.

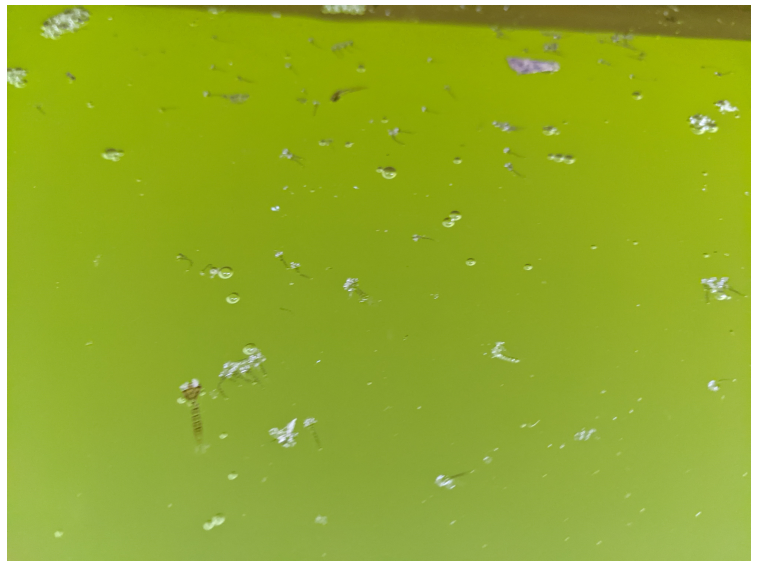
Picture 2

In the same wind-blown areas where the films were seen, large amounts of mosquito exoskeletons were seen floating on the surface (as seen in Picture 2). These are a great food source for fish but residents may notice an uptick in mosquitos as the larvae transition into adulthood.
