Lake Monitoring 2025

Prepared for Lake Tishomingo by Gateway Lake Management LLC

Visit Date: Tuesday 9/2/2025

Visit 11 Observations

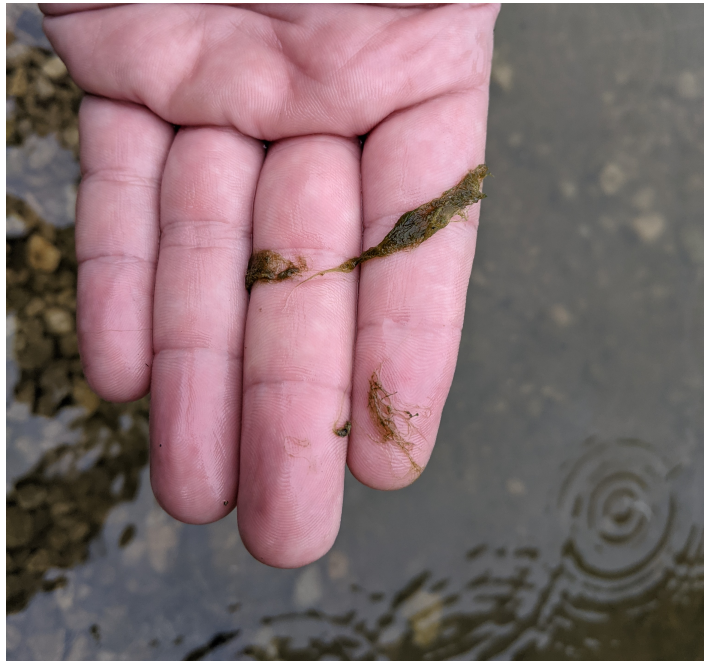
Picture 1

The planktonic bloom is at a minimum, barely detectable with 4+ft visibility. The only vegetation seen was a small amount of filamentous algae in shallow rip rap areas (as seen in Picture 1). The weed rake is coming up clean of any submersed vegetation.

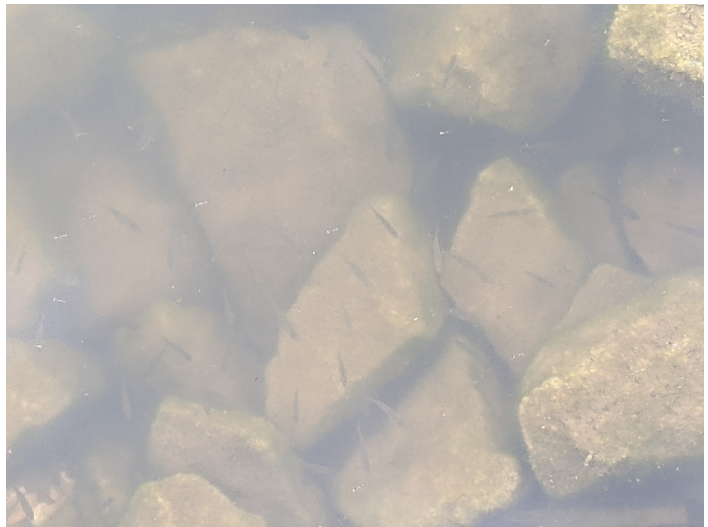
Picture 2

With cool temperatures and intermittent showers, higher oxygen parameters and fish activity is expected. Changes in seasons should trigger a good bite from most species present as they prepare for winter. Many baitfish were seen around docks and shallow rocky areas (as seen in Picture 2). The unusual cool front has created ideal conditions for the lake as we progress into September.
