**REITZ & JENS, INC.**  
CONSULTING ENGINEERS

December 8, 2010

Re: Site Visit / Spillway Inspection – December 2, 2010

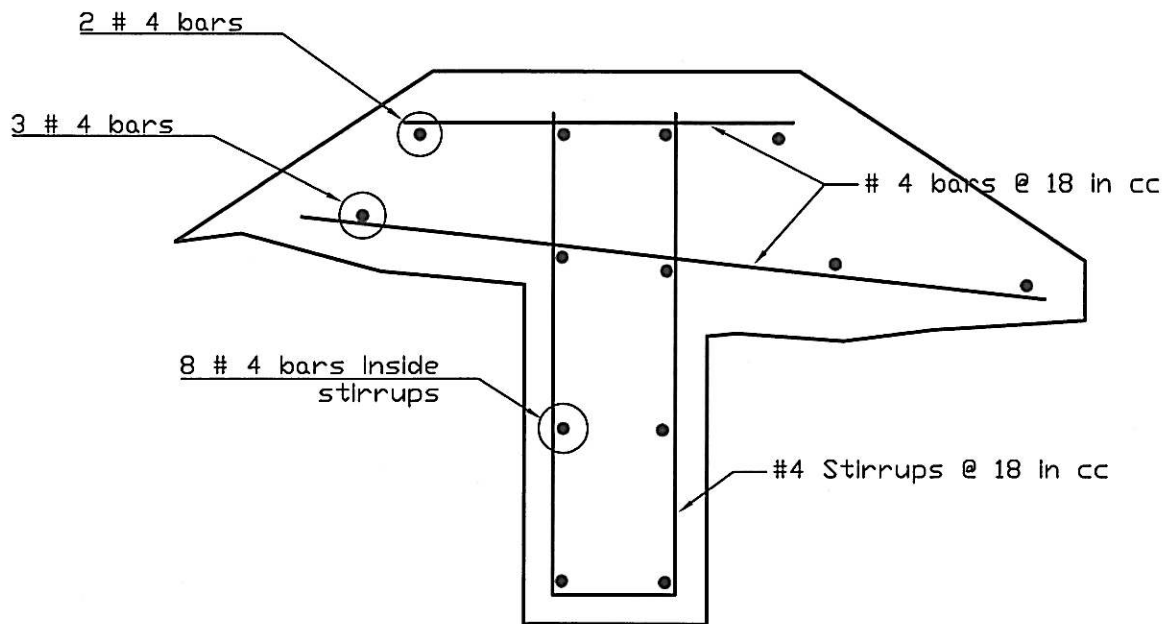
Section thru Spillway & ForceMain

It is important to recognize that the placement of the sewer across the spillway will effectively eliminate the possibility of cutting a trench into the spillway to lower the lake. The reinforced replacement spillway can be built with cold joints in it at selected locations to allow removal of part of the spillway, although it will not necessarily be the easiest task since the cutoff wall is cast into the rock.

The undermining of the spillway crest and the lack of a cutoff wall below the crest apron should be improved by replacement of a new spillway crest with a minimum 6 foot deep cutoff wall. We have prepared a typical section of the recommended replacement; these plans are attached to this memo and were previously sent to the committee. The top width of the spillway is not fixed, it can be varied to suit the needs of the membership. The spillway **MUST** be rebuilt no higher than the elevation of the present spillway, in order to avoid obtaining a permit from the MO Dam and Reservoir Safety Council. Replacement of the deteriorated spillway crest at the same elevation is considered routine maintenance and will not require a permit.

During excavation of cutoff wall, if any loose soil is encountered below cutoff wall, it should be removed and backfilled with extra concrete.
